**After Action Report**  
**Addressed Mosquito Breeding Habitat**  
**2020**

Sea Girt National Guard Training Center  
Updated August 2020

Stockton University Environmental Internship Program (SUEIP)  
School of Natural Science and Mathematics (NAMS)  
Stockton University, 101 Vera King Farris Drive  
Galloway, NJ 08205  
SUEIP Project Faculty Advisor: Tait Chirenje  
SUEIP Program Manager: John Hallagan

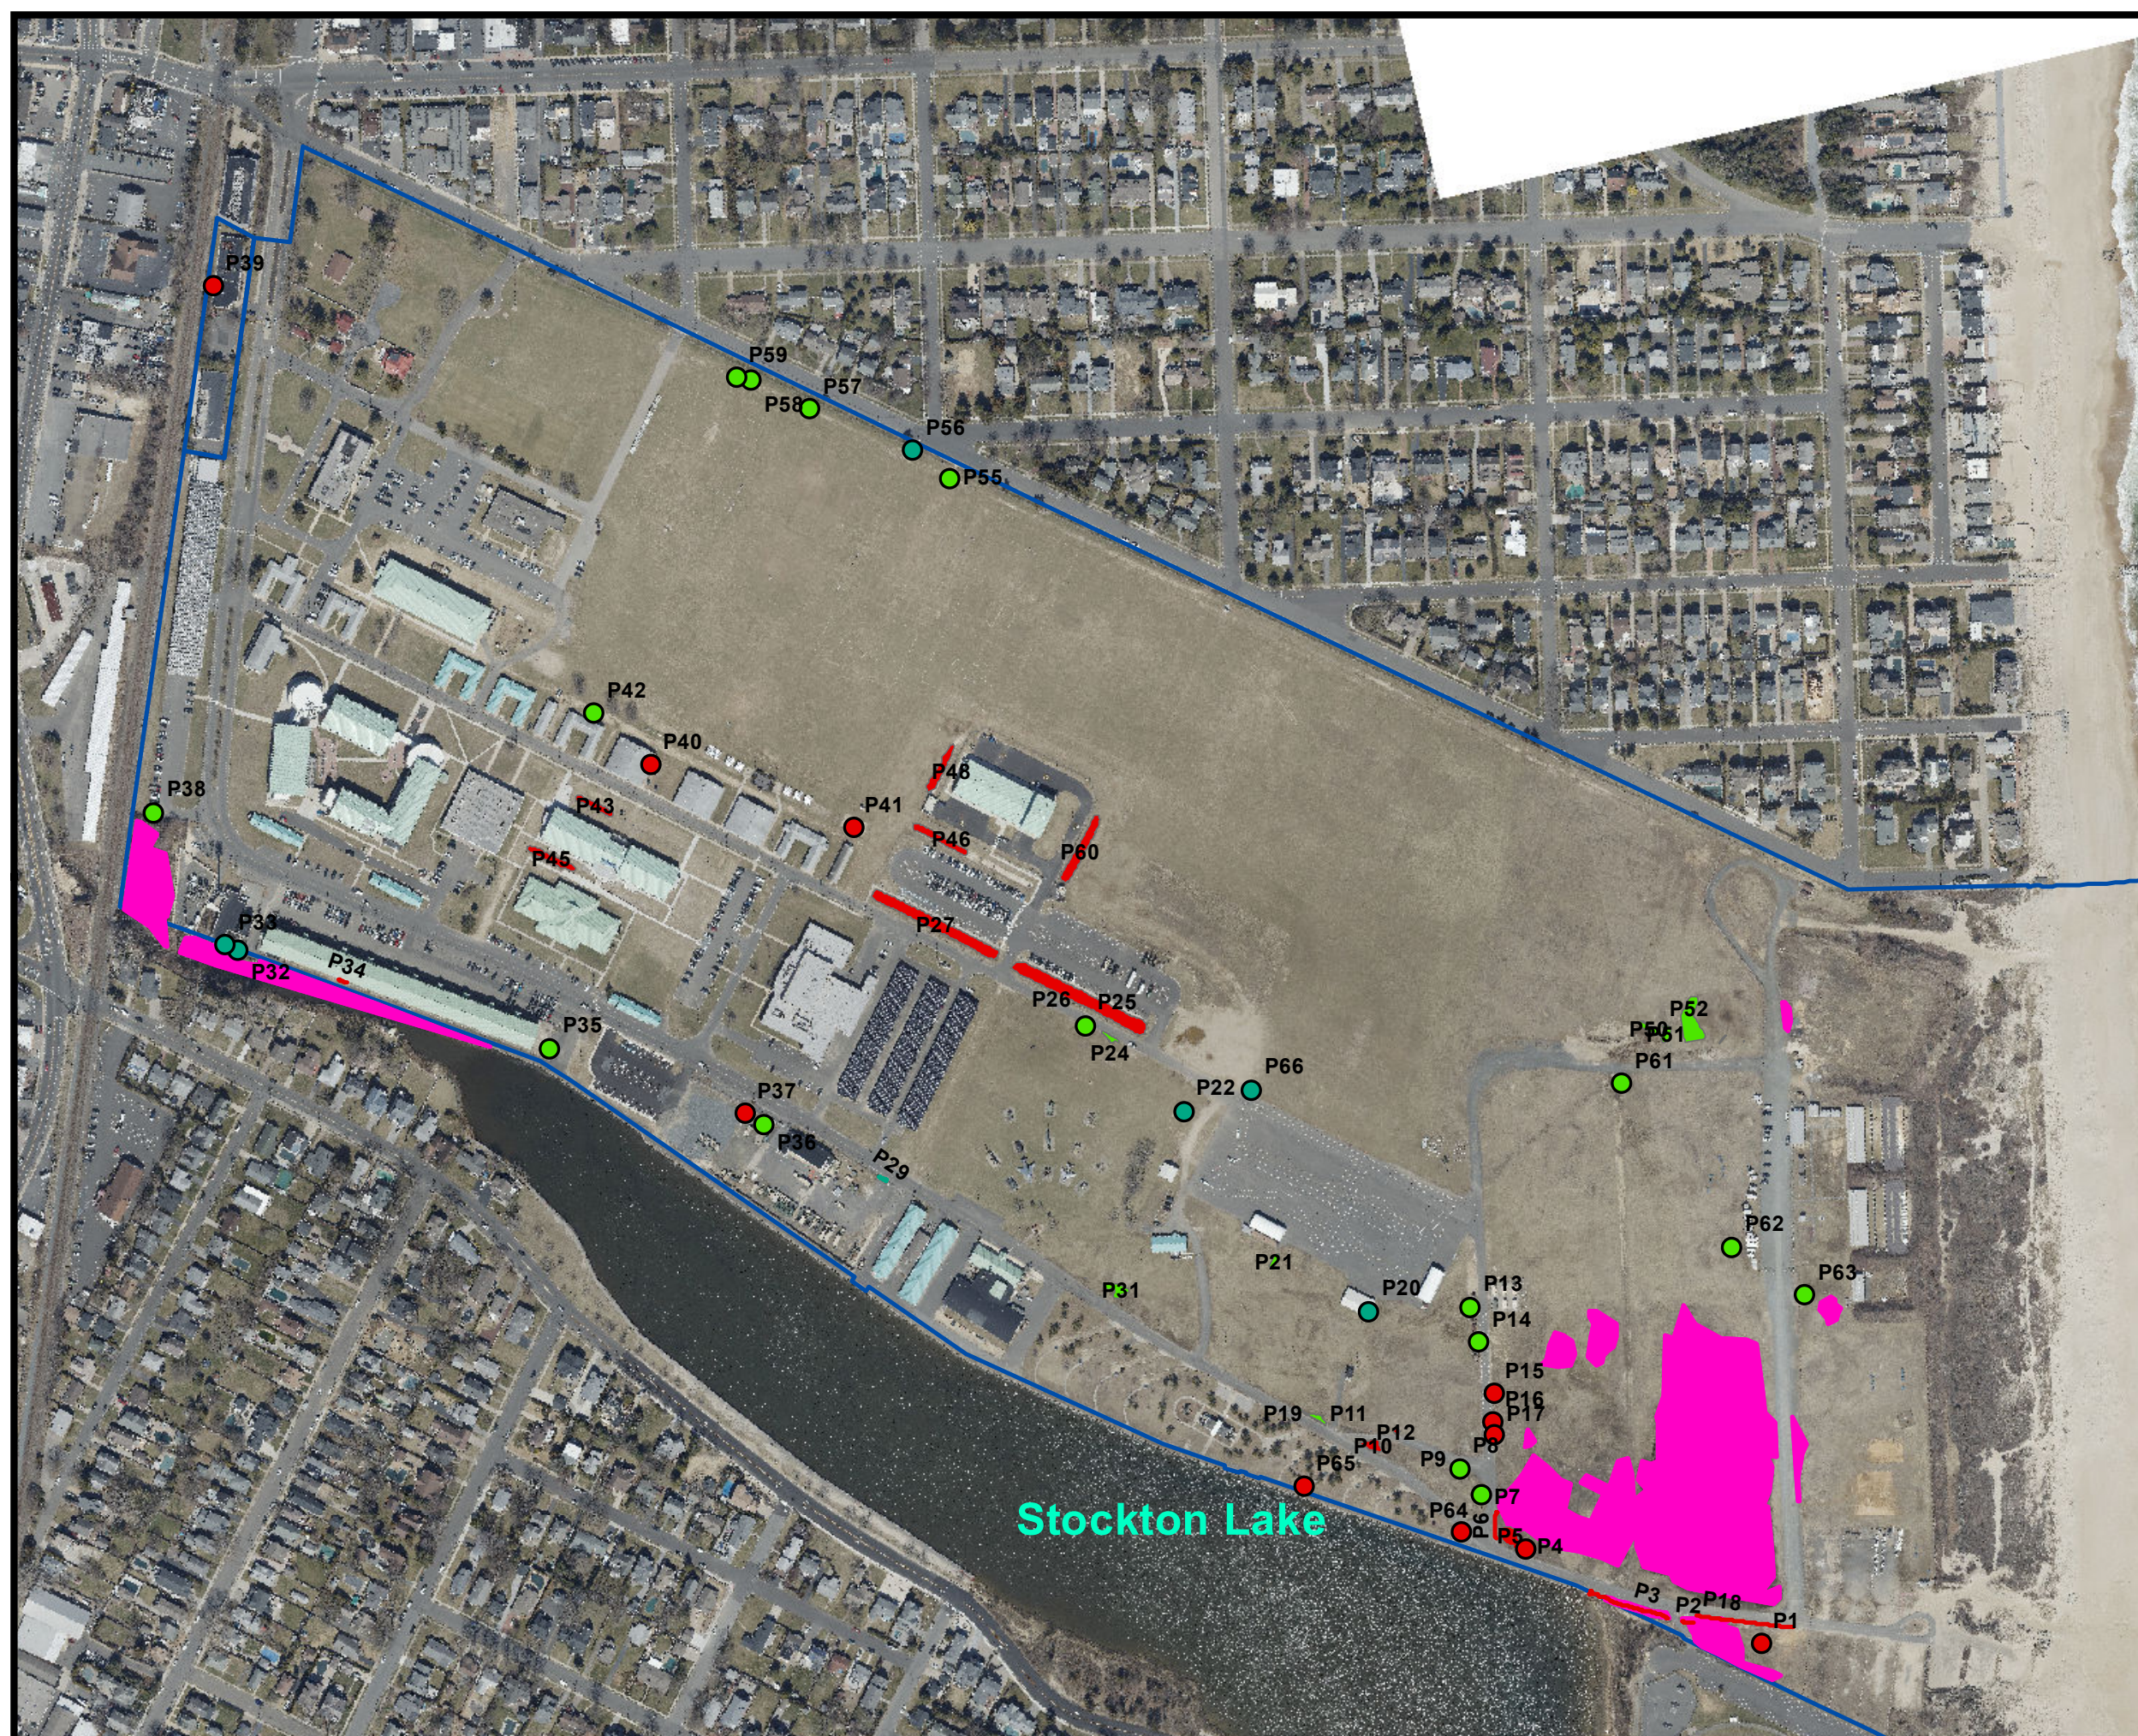
# Figure SG1 Sea Girt National Guard Training Center Mosquito Breeding Habitat August 2020

- Dry and/or Not Present
- Fixed/Addressed
- Not Addressed

Efforts to address the 65 potential mosquito breeding habitats were conducted by Environmental Management Bureau (EMB) staff and the Stockton University Environmental Internship Program (SUEIP) advisor, with cooperation from Keith Prout (crew supervisor of repairers) on August 14, 2020 and August 19, 2020. Of the initial 65 areas identified in June, 24 were found to be dry upon arrival. These areas are no longer considered to be potential mosquito breeding habitats considering this site had received rain 2 days prior, and mosquitos require approximately 9-16 days of standing water in-order to develop and emerge. Four locations, including the display missile (P13), display tank (P14), pallets (P35), and plastic tarp (P38) had been previously removed. The HEMTT pad and catchment basin (P36) had also been demolished and removed. Four locations observed collecting water in June, such as tires, trash can lids, and metal flashing were moved or overturned to prevent water from collecting. A front-loading tractor was used to fill 4 locations (P11, P22, P23, P66) with dirt to eliminate depressed or compacted areas. P10 was partially filled with dirt, however as stated in the section 3.0 below, additional efforts will be needed to address the drainage issues for that location. Surveyors also identified 1 additional location of roadside compaction (P66), which they also filled with dirt. Of the initial 65 locations identified, 37 have either been addressed, were dry upon arrival, or are no longer present. Twenty-eight locations have not been addressed, including 10 locations of compaction or depressions along roads or in fields, 9 retention basins or naturalized infiltration strips, the opening beneath the loading dock along the back of building 60, the bucket on the tractor near building 36, the condensation discharge from the AC unit behind building 2A, and the large tires used for training near building 21. Table SG1 includes a list of all 66 locations, the status of each location, and any methods used to address them. Figure SG1 portrays the location and status of all 66 locations. All non-addressed locations are portrayed on Figure SG2.

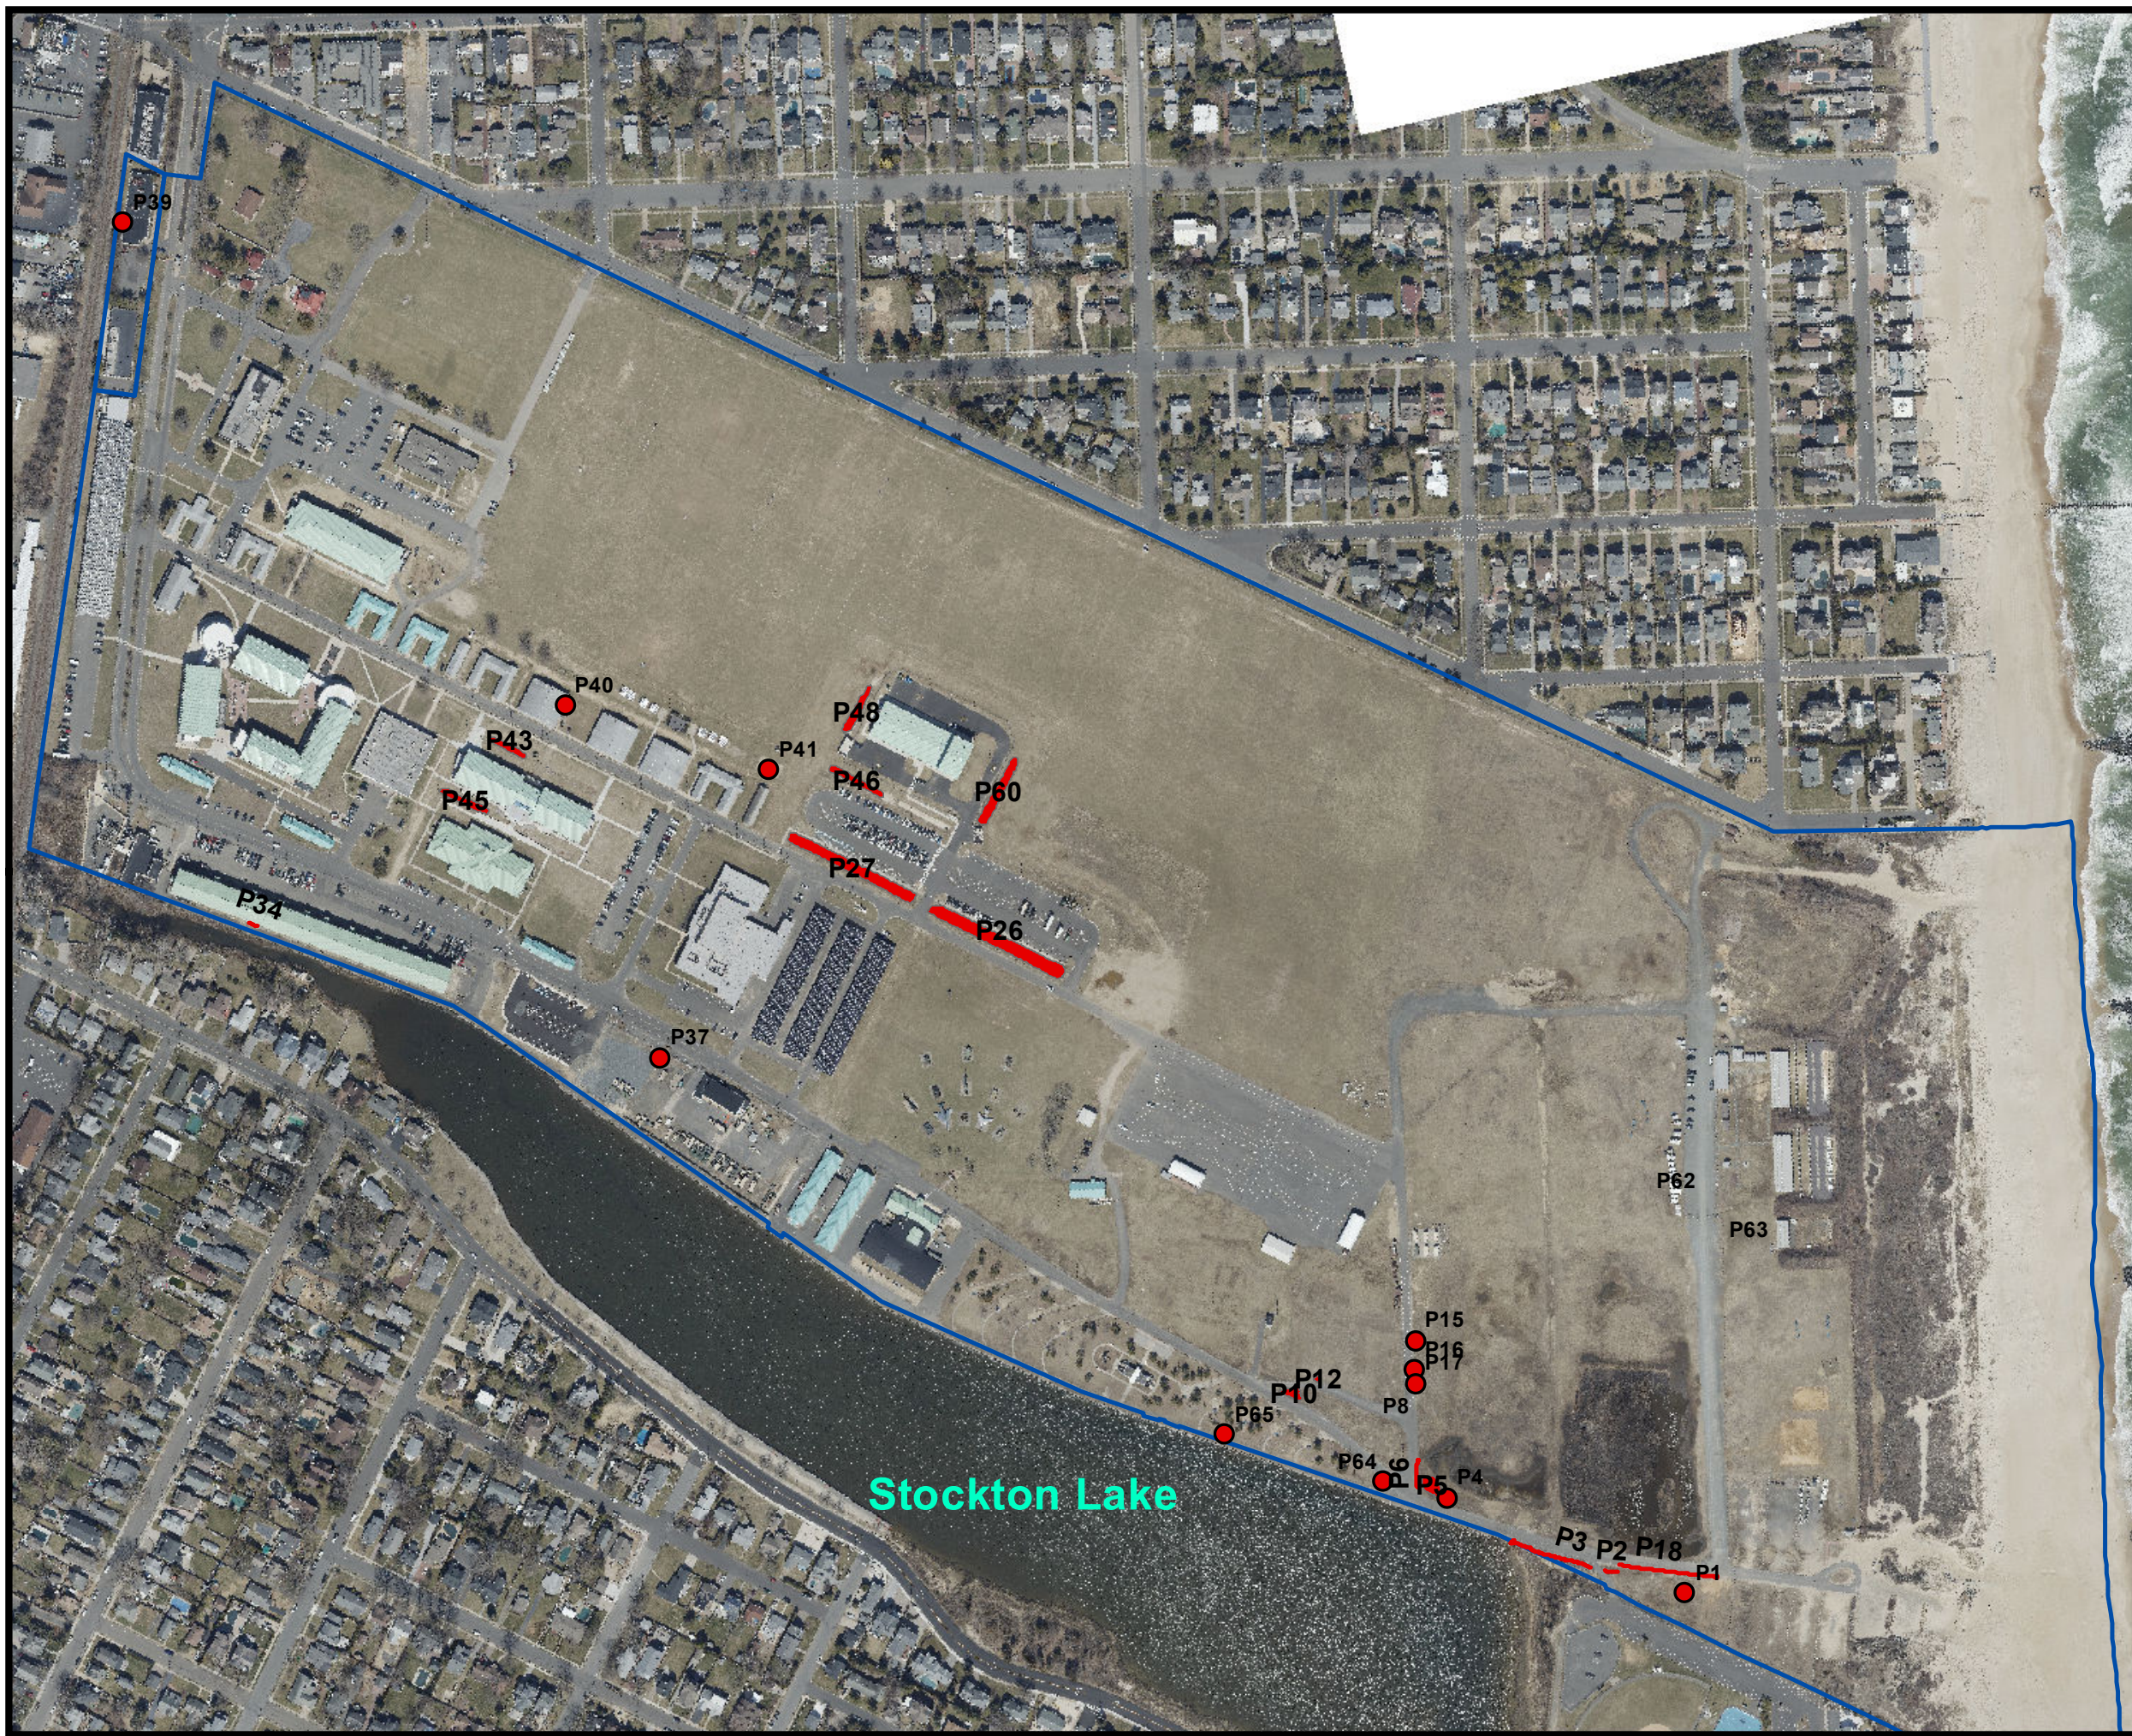
**Figure SG2**  
**Sea Girt National Guard**  
**Training Center**  
**Remaining Mosquito**  
**Breeding Habitat**  
**August 2020**

Not Addressed

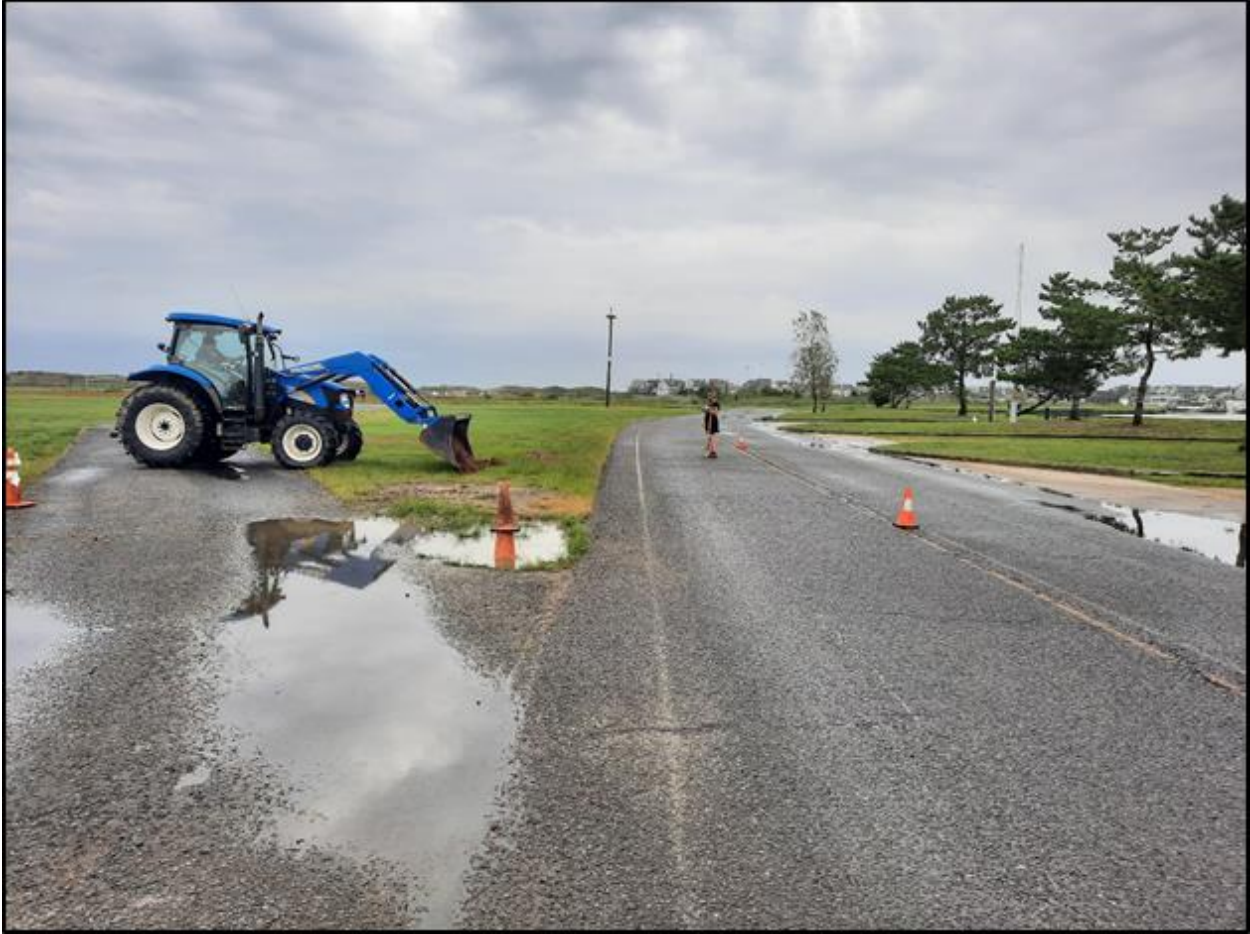
SG-MBH-2 Mosquito Breeding Habitat P10

P10 – Roadside Compaction

- P10 is a highly compacted area along a roadway. Compaction from vehicles at this location is likely to continue. Any attempts to fill this area with dirt may result in sediment runoff onto the road. It is recommended that a storm drain be installed at this location, and possibly connected to the storm drain system near P12

- Seed the dirt areas to prevent erosion and sedimentation onto the roadway
